Manhole Inspection Summary

Manhole # S17M__014MH

Insp Date: **4/11/08 1:42 PM**

Location Address: **2624 sloatfield-lehman alley**

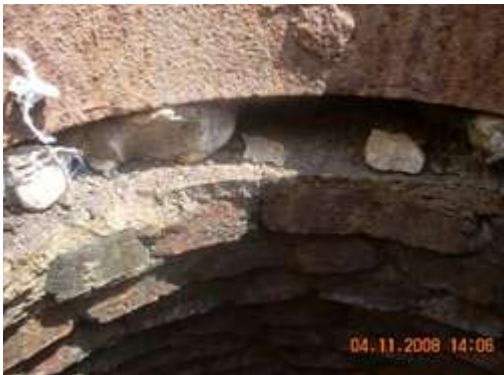
Defect 1

Condition: ☐ Sound ☐ Cracked ☐ Root Intrusion ☐ Loose Brick ☒ **Deteriorated**

deteriorated chimney

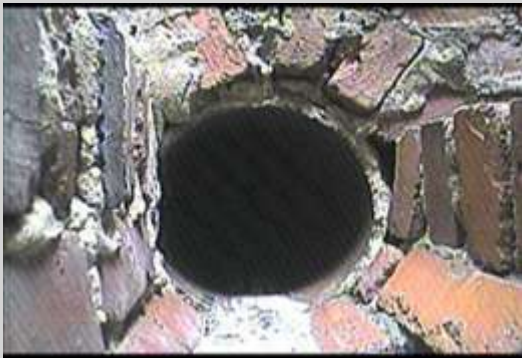
12 O'Clock Outflow

8 in. Circular Gravity Sewer
Pipe Out @ 12 O'Clock

Pipe Height: **8.4** (in.) Rod and Bar (Angled)
Pipe Material: **Clay** ☐ Pipe Lined
Invert Depth: **5.74** (ft.) Flow Characteristics: **None**
Deposits: ☒ None ☐ Mud ☐ Sludge ☐ Debris ☐ Grease
Silt Depth: **0** (in.) Deposits Extent:
Infiltration: **None** Pipe Seal Cond: **Sound**

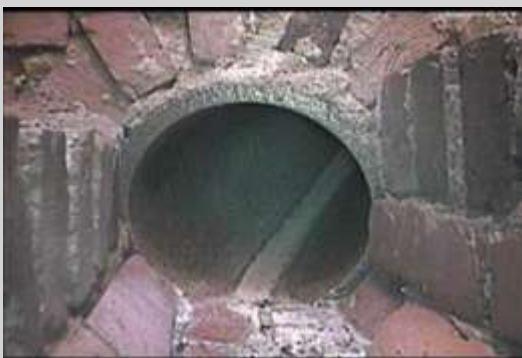
6 O'Clock Inflow

8 in. Circular Gravity Sewer
Pipe In @ 6 O'Clock

Pipe Height: **8.4** (in.) Rod and Bar (Angled)
Pipe Material: **Clay** ☐ Pipe Lined
Invert Depth: **5.60** (ft.) Flow Characteristics: **None**
Deposits: ☒ None ☐ Mud ☐ Sludge ☐ Debris ☐ Grease
Silt Depth: **0** (in.) Deposits Extent:
Infiltration: **None** Pipe Seal Cond: **Sound**
